**DEPARTMENT OF TRANSPORTATION**

Contract #: 04-0120F4Cty: SF/ALA Rte: 80 PM: 13.2/13.9File #: 69.28**WELDING INSPECTION REPORT****Resident Engineer:** Pursell, Gary**Address:** 333 Burma Road**City:** Oakland, CA 94607**Report No:** WIR-003875**Date Inspected:** 10-Aug-2008**Project Name:** SAS Superstructure**OSM Arrival Time:** 700**Prime Contractor:** American Bridge/Fluor Enterprises, a JV**OSM Departure Time:** 1530**Contractor:** Zhenhua Port Machinery Company, Ltd (ZPMC), Changxing Island **Location:** Shanghai, China**CWI Name:** Sun Wei, Guo Yan Fei**CWI Present:** Yes No**Inspected CWI report:** Yes No N/A**Rod Oven in Use:** Yes No N/A**Electrode to specification:** Yes No N/A**Weld Procedures Followed:** Yes No N/A**Qualified Welders:** Yes No N/A**Verified Joint Fit-up:** Yes No N/A**Approved Drawings:** Yes No N/A**Approved WPS:** Yes No N/A**Delayed / Cancelled:** Yes No N/A**Bridge No:** 34-0006**Component:** Tower & OBG**Summary of Items Observed:**

## WELDING INSPECTION REPORT

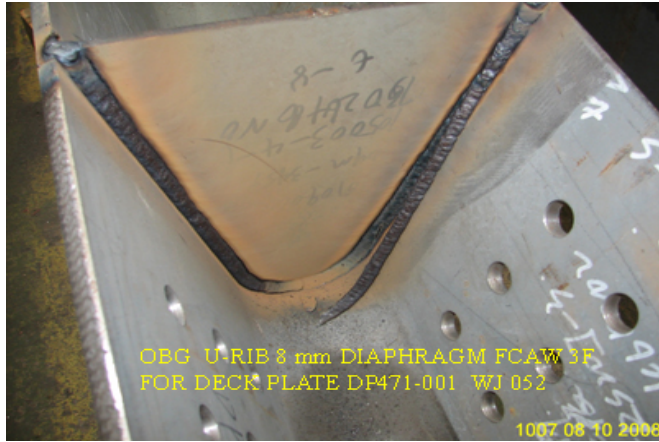
The QA Inspector randomly observed ZPMC welder Yang Yangzeng ID Number 059418, utilizing the Flux Cored Arc Welding (FCAW) Process in the 3F (Vertical Fillet) Position with ZPMC Weld Procedure Specification (WPS) WPS-B-T-2133 to weld 8 millimeter (mm) diaphragms into various U-Ribs for Deck Plate Sub-Assembly DP471-001. The QA Inspector randomly observed ZPMC QC monitoring weld parameters. The QA Inspector also randomly monitored weld parameters and recorded them as follows: 219 amps, 27.5 volts on Weld Joint (WJ) DP471-001-052. The weld parameters appeared to comply with contract requirements. The attached photograph provides additional detail.

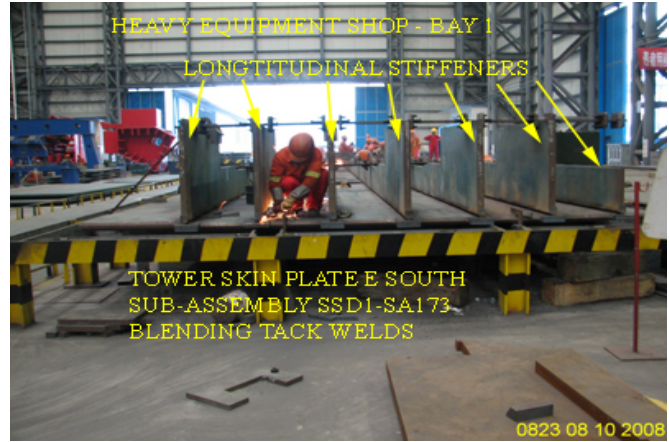
The QA Inspector randomly observed ZPMC 8 helpers utilizing angle grinders to blend the tack welds attaching longitudinal stiffeners to Tower Skin Plate E(S) Sub-Assembly SSD1-SA173. The attached photograph provides additional detail.
